**BIODETERIORATION OF STONE.  
AN EVALUATION OF POSSIBLE TREATMENTS AND THEIR EFFECTS  
WITH SPECIAL REFERENCE TO MARBLE STATUARY AT CLIVEDEN,  
GERMANTOWN, PENNSYLVANIA**

A THESIS

Historic Preservation

1997

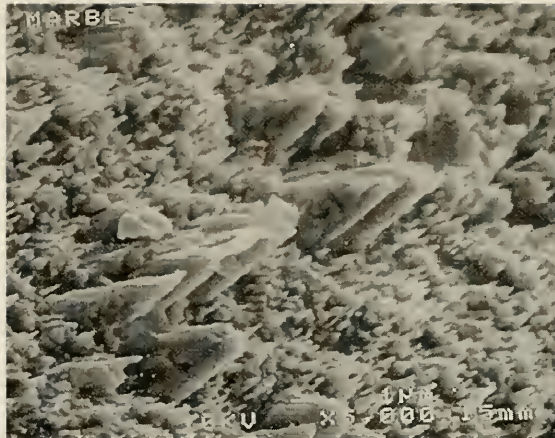
Figure 1. SEM Photo of Etched Marble.

A scanning electron microscopy (SEM) photo (following page) shows the type of etching that can occur as a result of chemical weathering from biological growth.

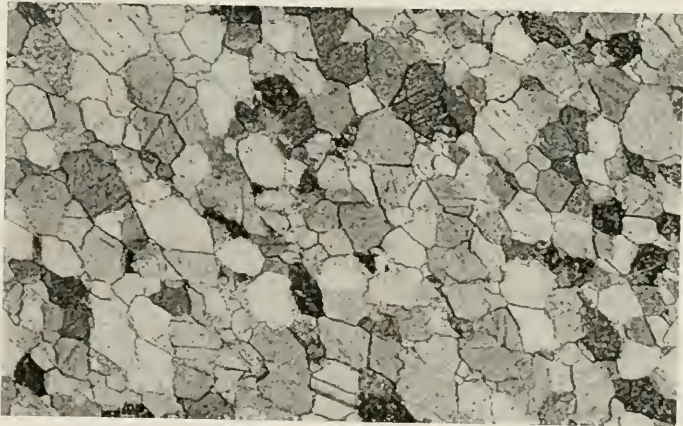
Stone F is pure calcite, with a compact, equigranular crystalline structure. No other mineral was found to be present with the exception of a few dolomite crystals. There is a high degree of lamellar twinning found, in one or two directions. This granoblastic stone exhibits a polygonal texture, where the majority of the grains are similar in size and five- or six-sided with three grains intersecting at a single point. The process called annealing produces an increase in grain size along with this texture. As smaller grains are subjected to high temperatures, they dissolve and their chemical components are taken up by the larger grains. The lack of elongation in the crystals indicates only a moderate amount of metamorphic pressure, which is conducive to annealing.

*Figure 2. Thin-section of marble, sample F, at 50X magnification. Note the equigranular crystalline structure of this annealed marble of nearly pure calcite; many crystals exhibit twinning.*

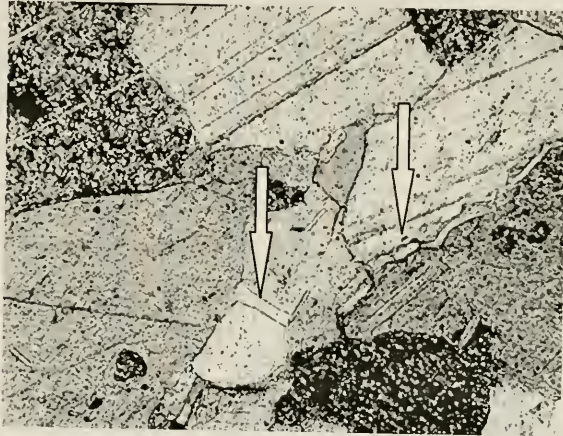
Stone E and Stone I are very similar in character. They are both formed of calcite along with numerous quartz deposits, both in small drops and along grain boundaries traversing the entire length of the thin section. Most grains have lamellar twinning in one direction. Grain size is varied and angular, with stone I exhibiting a greater angularity. There is a definite elongation of all grains, in one direction, evidence of metamorphic compression. One or two grains of dolomite are present.

*Figure 3. Thin-section of marble, sample I, at 100X magnification. This stone has numerous quartz deposits (at the arrow) and a few grains of dolomite. Grain size is varied and angular, with a definite elongation of all grains in one direction, evidence of metamorphic compression.*

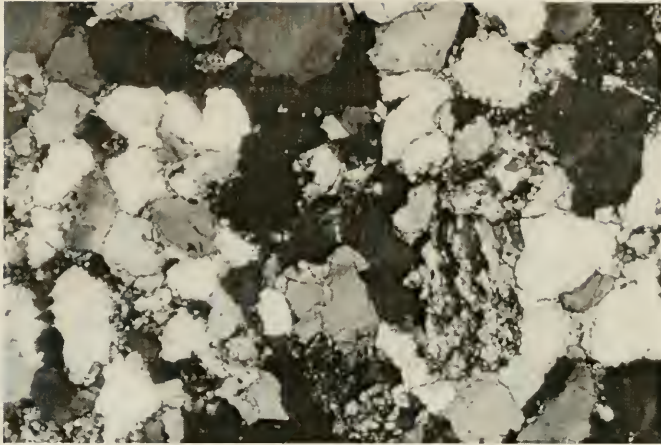
The sandstone, stone K, is classified as a quartz arenite due to its high quartz content. Small amounts of biotite and muscovite flakes are present, along with iron oxides and a few deposits of hematite. While many of the quartz grains are polycrystalline, very few are detrital - a characteristic common among sandstones. It is a well-sorted sample with very little fine-grained matrix.

*Figure 4. Thin-section of sandstone, sample K, at 50X magnification. Its high quartz content, many of which are polycrystalline, classifies this stone as a quartz arenite. Its composition includes small amounts of mica along with iron oxides.*

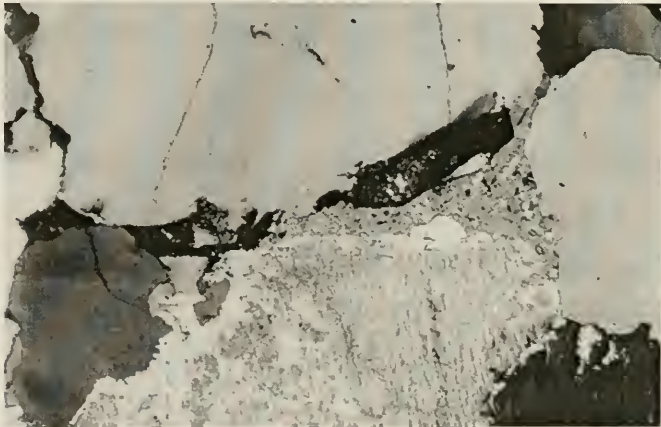
The granite, stone J, is a coarse-grained biotite granite with deposits of quartz (some polycrystalline) and feldspars. Many of the feldspar grains exhibit perthitic texture, an intergrowth of plagioclase and potassic feldspars that occurs during cooling.

*Figure 5. Thin-section of granite, sample J, at 50X magnification. This stone is a biotite granite with quartz and feldspar deposits. Many of the feldspar grains exhibit perthitic texture.*

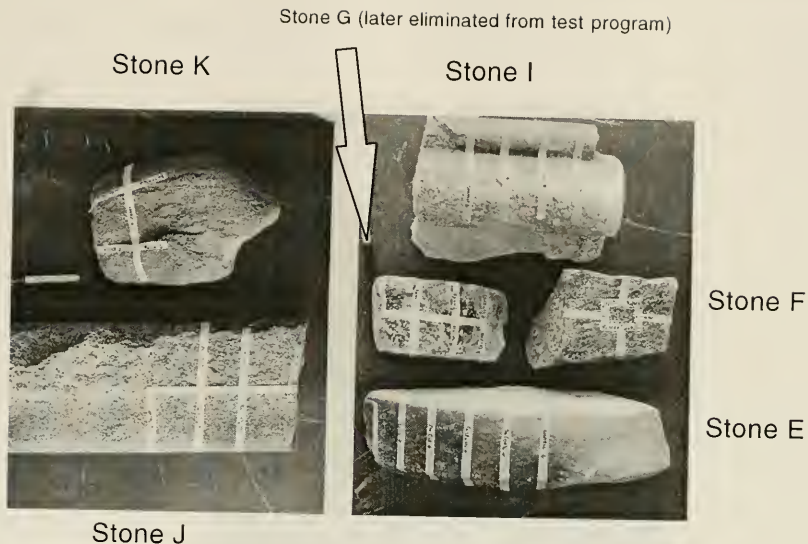
**Figure 6. Stones before first poulticing. Each treatment area was marked off with masking tape and labelled appropriately.**

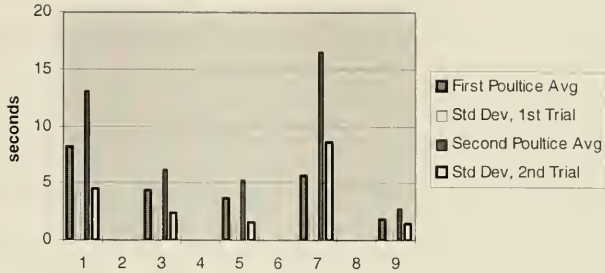
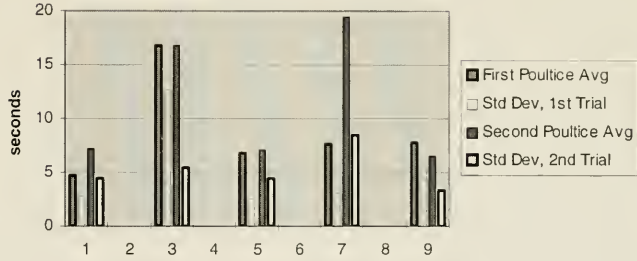
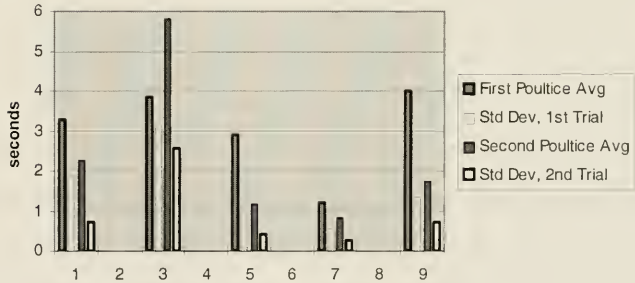
Figure 8. Micro-Drop Absorption Time Comparisons of Marbles.  
 (1= $\text{CaCl}_2\text{O}_2$ , 3= $\text{Ba}(\text{OH})_2$ , 5= $\text{NaOCl}$ , 7= $\text{H}_2\text{O}_2$ , 9=Control)

Differences in the absorption times can, in some cases, be attributed to variations in biological growth between the stones.

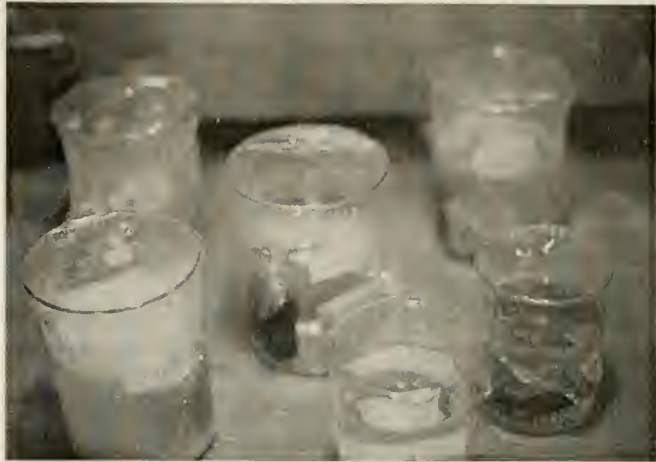
A single layer of 6mm glass beads was placed at the bottom of each beaker of solution. Two stones (one marble, one sandstone) were then placed in each beaker, upright on the beads, with the solution completely covering the stones. Two control stones were placed in beakers of deionized water.

*Figure 9. Samples Totally Immersed in Treatment Solutions.*

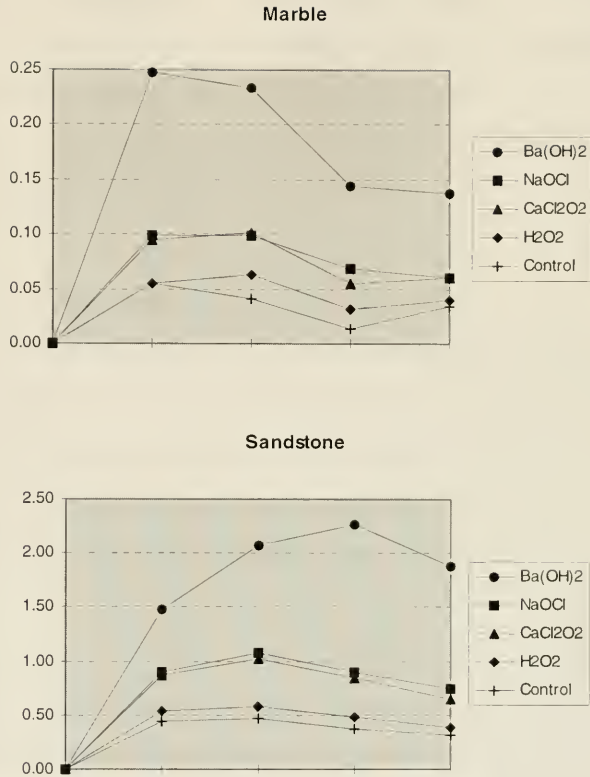
Figure 11. Hygroscopicity Test - Relative Weight Increase Percentage.

The data were graphed to facilitate interpretation (Figure 11). The graphs show the percentage of weight increase over four weeks time. The rapid initial weight increase evident for all samples can be explained by the drastic change in environment, from the dry dessicator chamber to the 100% RH of the plastic tub. As equilibrium conditions are established the curves level off.

As expected, the hydrogen peroxide results match up closely with that of the control, indicating a very minimal increase in hygroscopicity. This is not the case for the sodium hypochlorite and calcium hypochlorite solutions, which read nearly identically. These reveal a doubling in percentage weight gain as compared to the control, indicating a marked augmentation in hygroscopicity due to the presence of salts, NaCl and CaCl<sub>2</sub>,

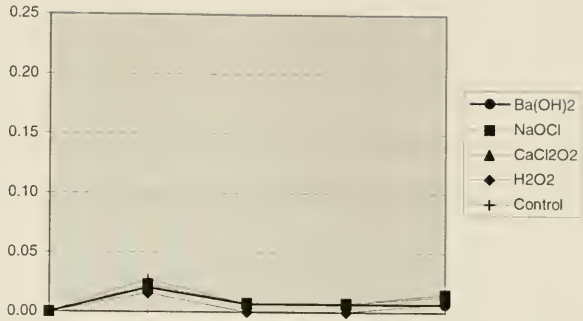
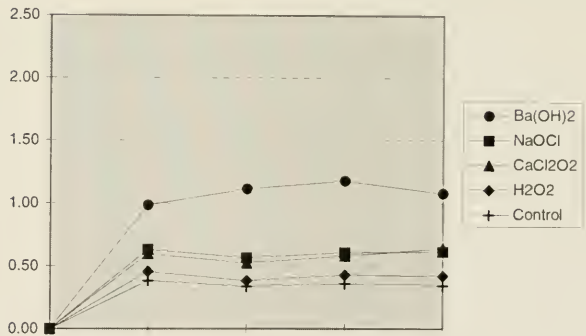
Figure 12. Hygroscopicity Test - Relative Weight Increase Percentage After Soaking.

Both hypochlorite solutions leave behind soluble salts of hygroscopic nature, increasing hygroscopicity significantly and doubling the relative amount of moisture absorbed.

The case of barium hydroxide is more complex, since in this case not only moisture but carbon dioxide are taken from the air, which is reflected in the reported curves (see Figures 11 and 12). Some of the unreacted base may have been removed (initial weight after soaking is lower than original) and is reflected in the lower absorption followed in the second run. However, the soaking may have brought out the residual  $Ba^{++}$  ions to the surface thus forming the visible efflorescence which increased with time.

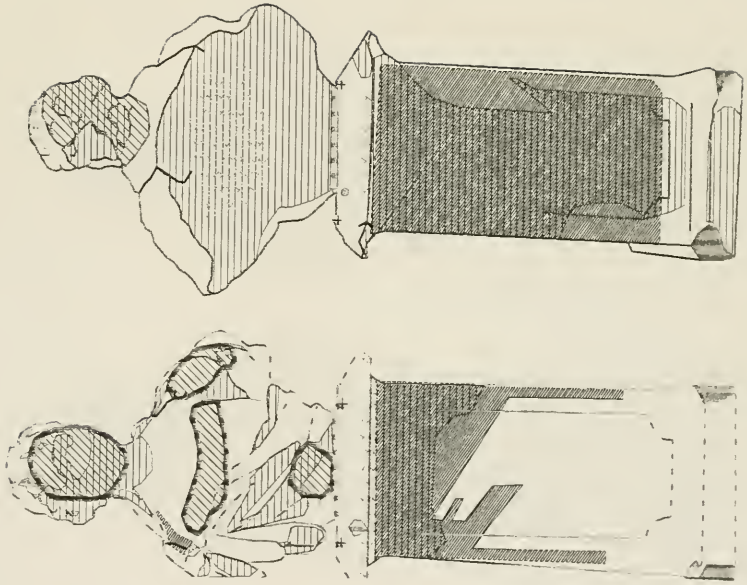
Figure B-4. Female Bust.  
Accession No. NT 73.55.4(1).

The female bust experiences a microclimate of full sunlight and exposure to winds while the male bust is shaded, protected from wind, and in proximity to a city street with its accompanying soot and pollution. These two statues at Cliveden, presumably of the same marble but with significant differences in biological growth, clearly illustrate the point made by Urzi, Krumbein, and Pernice (Urzi et al. 1992) who demonstrated that microbial activity varies dependent upon microclimatic conditions.

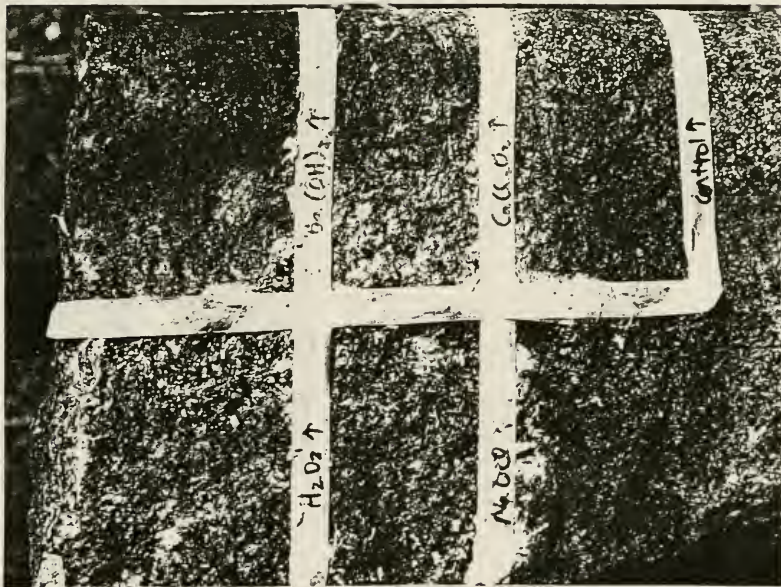
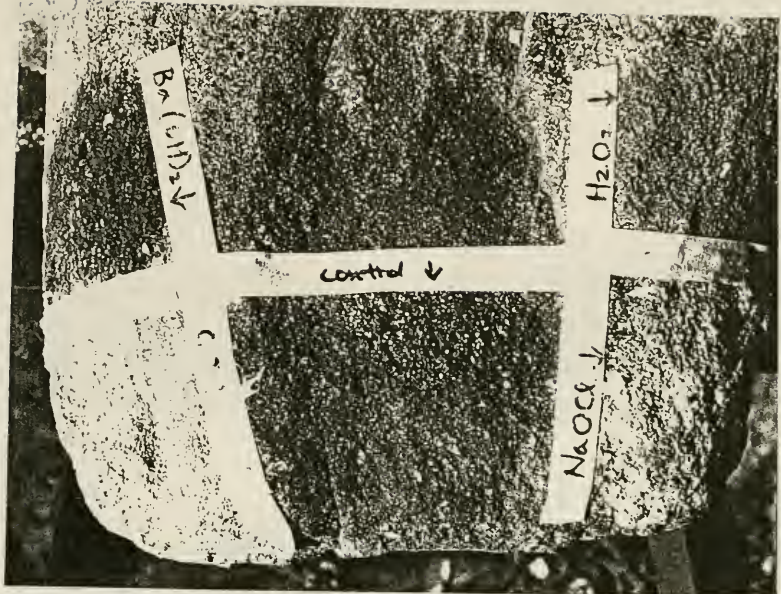
Figure G-1. Stone J - granite (left) and stone K - sandstone (right) after treatment.

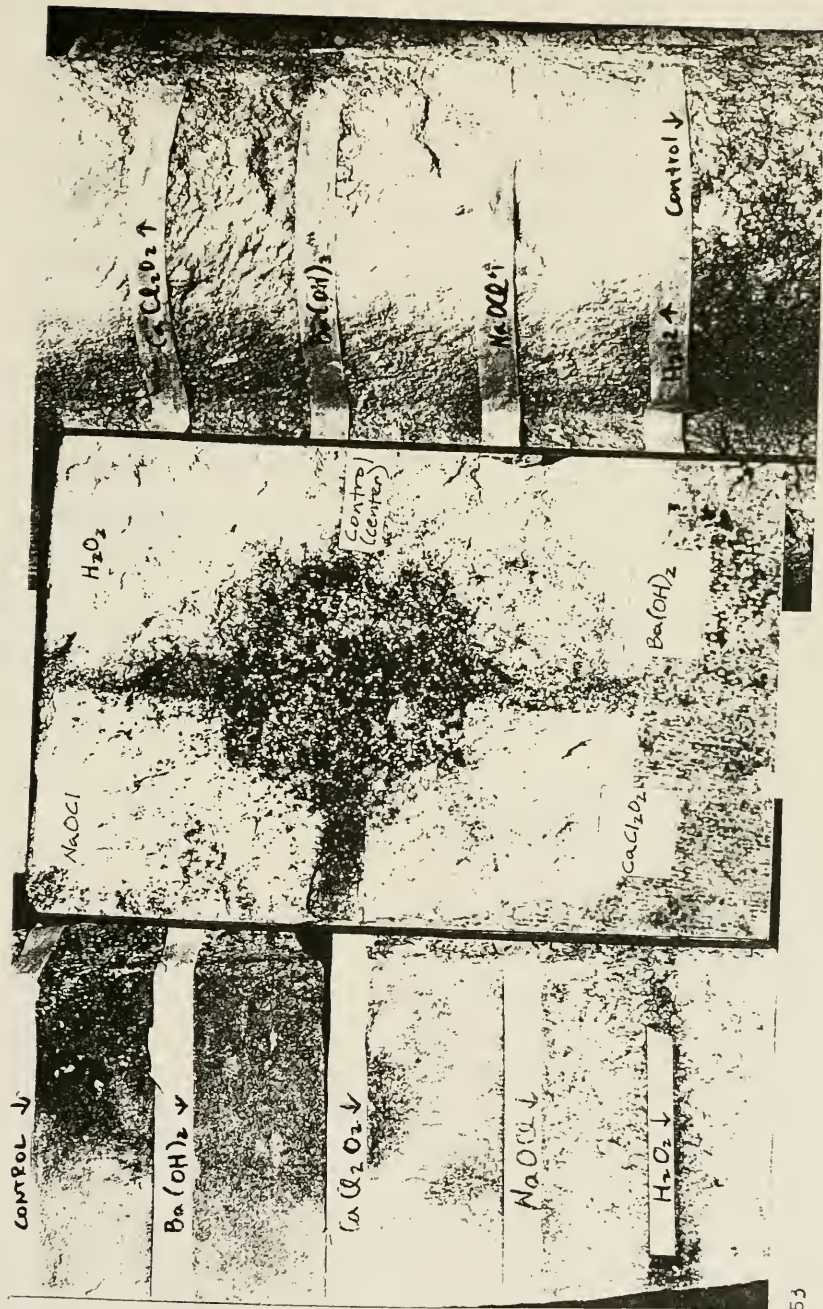
Figure G-2. Stone E (left), stone F (center), and stone I (right) after treatment.
